## **PART 4**

# **GEOPHYSICAL SURVEY BY USING ELECTRICAL RESISTIVITY TECHNIQUE**

## **DAM SEEPAGE STUDY AT SEMBRONG DAM JOHORE BY USING ELECTRICAL RESISTIVITY**

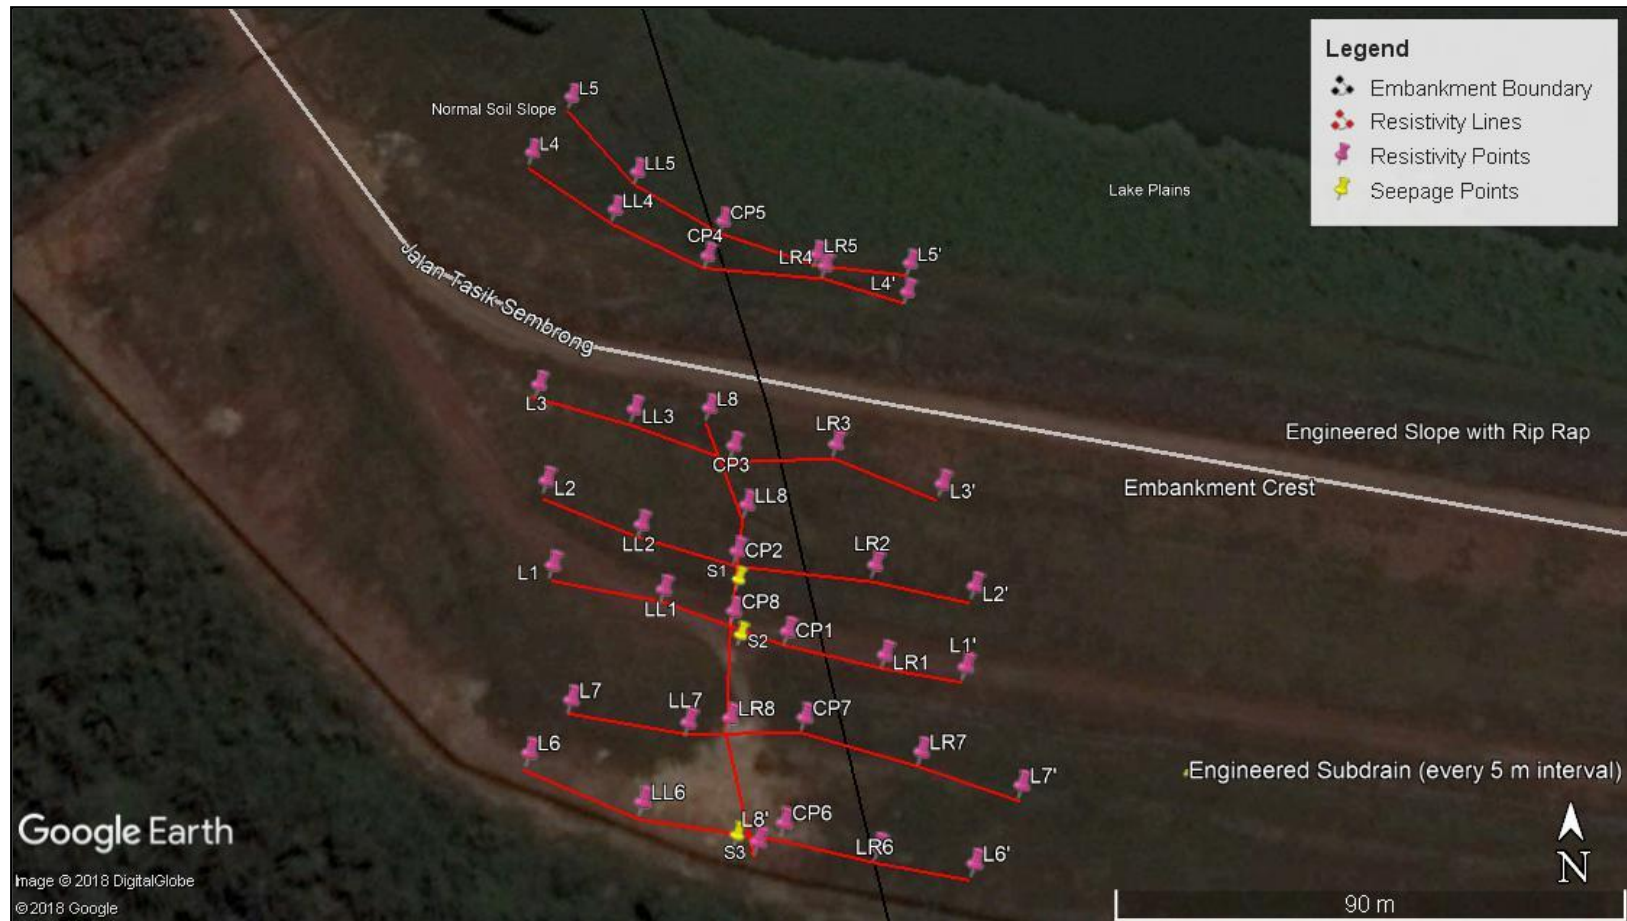
Figure 4.1: Location of electrical resistivity survey lines

The ERM was carried out involved two-dimensional (2-D) imaging resistivity survey. The transverse survey distance was ranges about 80m which depend on the space provided in undulating area that was not more than 45 degree. The Wenner-Schlumberger configuration was chosen based on space provided in flat area and the depth of penetration interest in order to identify the presence of subsurface lithologies and groundwater occurrence. **EIGHT (8)** resistivity survey lines (Figure 4.1) were conducted at parallel and perpendicular orientation within study area.

Resistivity survey line L1-L1' located parallel at the back of the dam embankment (Figure 4.1) The resistivity image for the L1-L1' showed low resistivity values range between 10 to 150 ohm.m especially in the area of seepage points (S1 / S2) (Figure 4.4). It is believed that the low resistivity value shown in the seepage points is caused by the presence of high-pressure head occurs and followed to the equipotential line direction to the end of dam embankment. This pressure induced high pore water pressure and release by follow to natural seepage drainage created by pore water pressure to the seepage points. It is believed that the seepage occurred at the boundary connection area between the engineered material dam (right side) and the natural material dam (left side) from the center point (CP1) as shown in the image of resistivity line, L1-L1 '(Figure 4.4).

Resistivity survey line L3-L3' located near the crest embankment dam (Figure 4.1). The resistivity image indicated that there is a low resistivity value (10-150 ohm.m) presence at the engineered material dam (right side) of the resistivity image from CP3 (Figure 4.6). This is due to percolated water that occurred filling in the fracture space of the dam embankment. Photos in the appendix on lines L3-L3' showed that soil depression occurs in the area on dam surface and possible caused by due to the formation of cavities, sinkholes or cracks. The second possibility is due to the presence of chimney drain in the area which is a vertical waterway before going to the drainage blanket (horizontal).

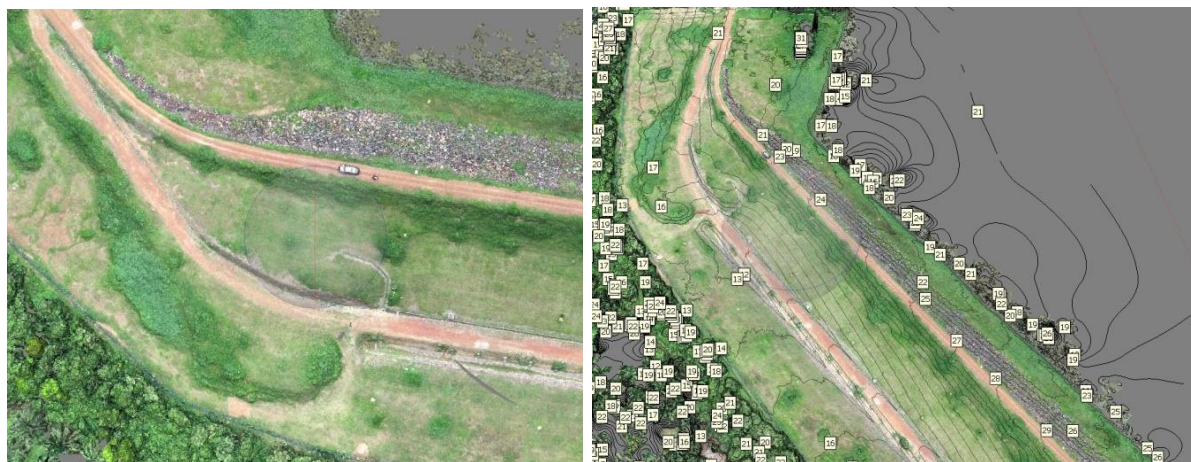
**Figure 4.2:** Elevation and generation of textured model

The exact locations, namely longitude and latitude of the transverse survey points were determined in the field with the help of Global Positioning System (GPS), Garmin Etrex Model and Unmanned Automatic Vehicle (UAV) drone. The horizontal accuracy of GPS is nearly 3-4m when the strong satellite signals were detected. Tables 4.1, 4.2, 4.3 and 4.4 showed the coordinates measured from transverse survey labeled. To locate the high topographical form of dam ground, aerial images are used to construct the contour of elevation (N, Ellipsoid height). The Agisoft PhotoScan can align essential 2D model point after all the image information has been synchronized. The 2D model was built with 120 camera stations and 378 646 tie projections. Then all the point clouds are used to build dense point cloud. Next step is to construct the dense point cloud to mesh the 2D map together, producing a shaded model form. Textured model will generate a smooth texture of full 3D model. Figure 4.2 shows full elevation and generation of textured model at study area.
